Subject: Geotechnical and Geologic Research
Pinole-Hercules Water Pollution Control Plant Upgrade Project
Pinole, California

This letter report summarizes the results of our geologic and geotechnical research for the Pinole-Hercules Water Pollution Control Plant (WPCP) Upgrade project.

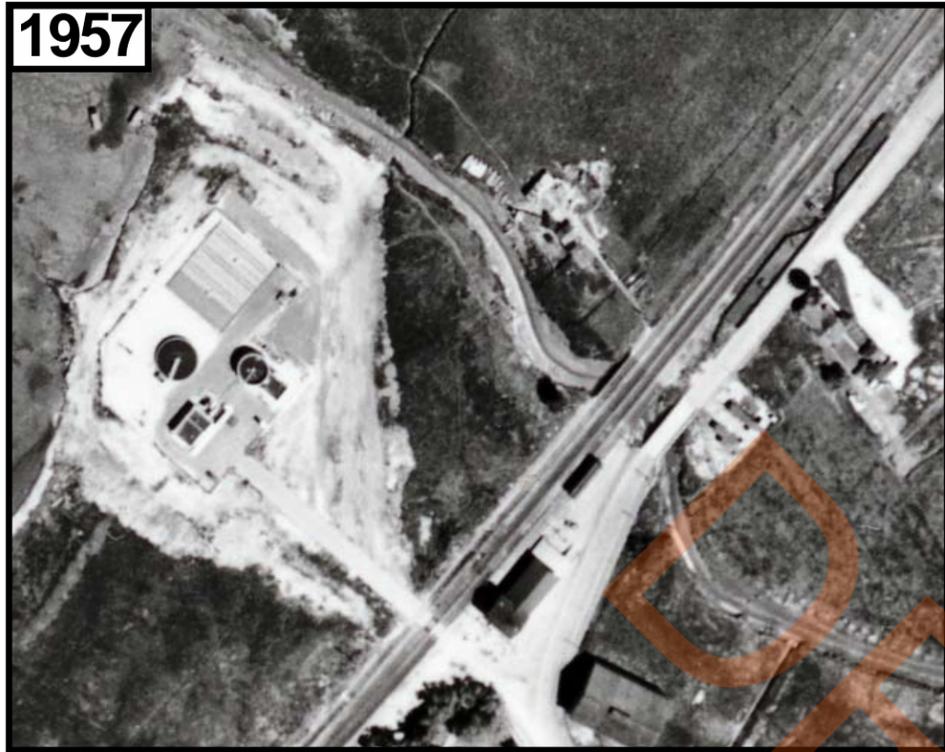
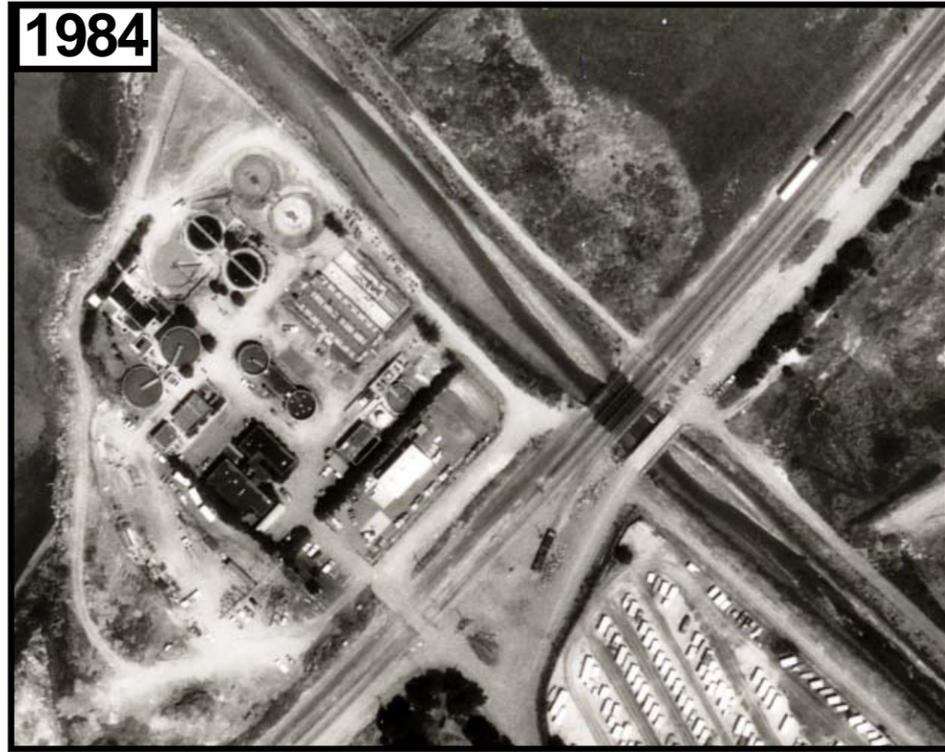
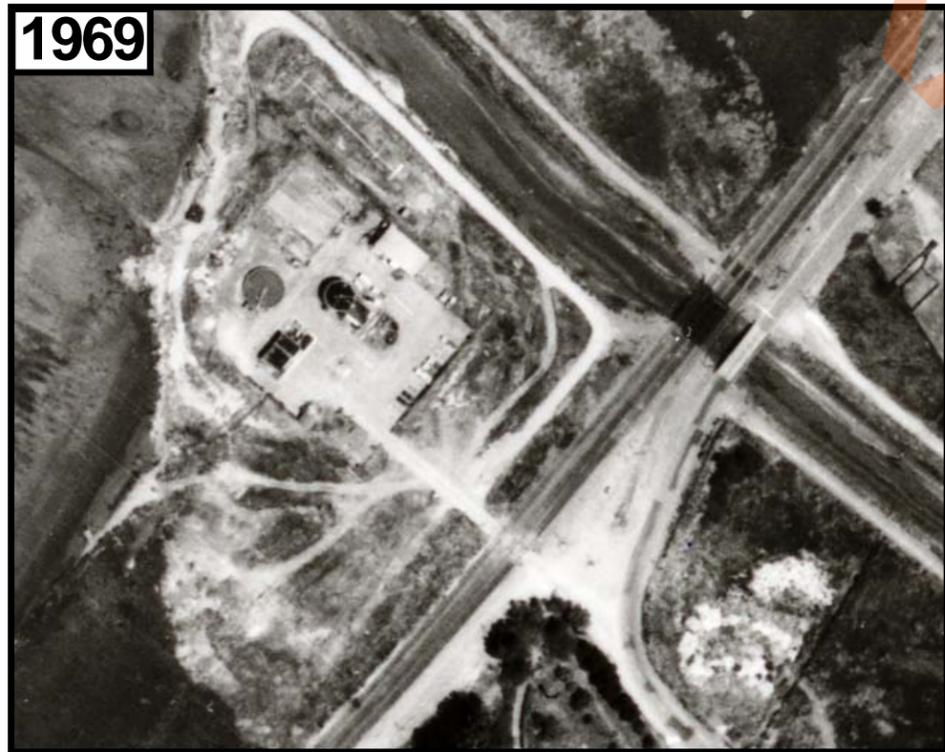
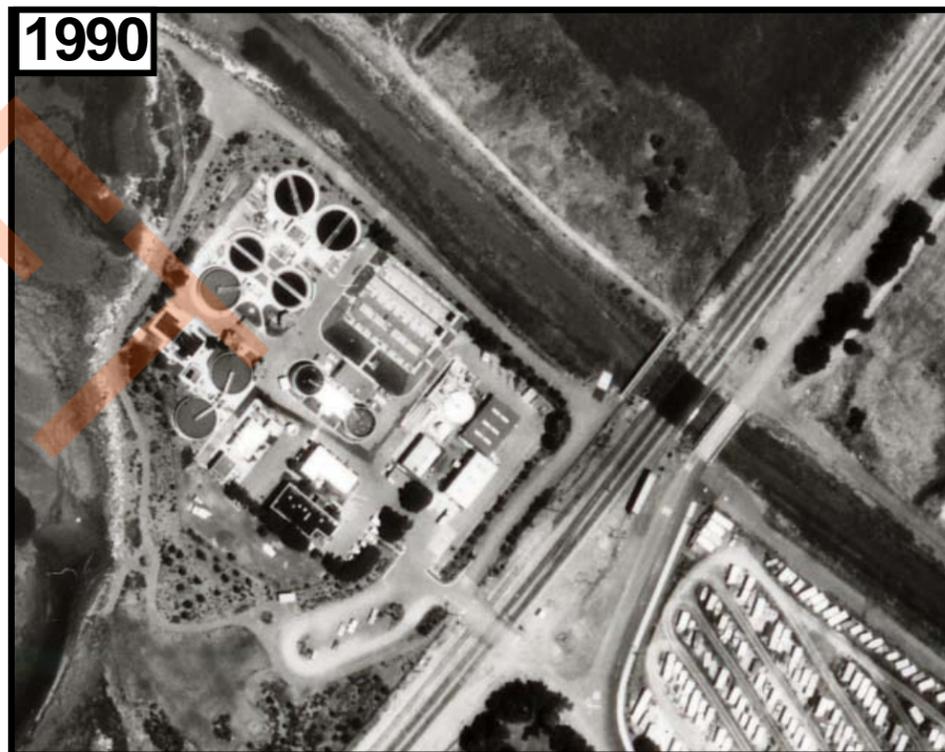
Historic Air Photos

Portion of Pacific Aerial Surveys AV 253-07-02, dated 5-3-57

Portion of Pacific Aerial Surveys AV 2480-03-52, dated 5-17-84

Portion of Pacific Aerial Surveys AV 902-11-02, dated 5-19-69

Portion of Pacific Aerial Surveys AV 3845-06-01, dated 6-12-90

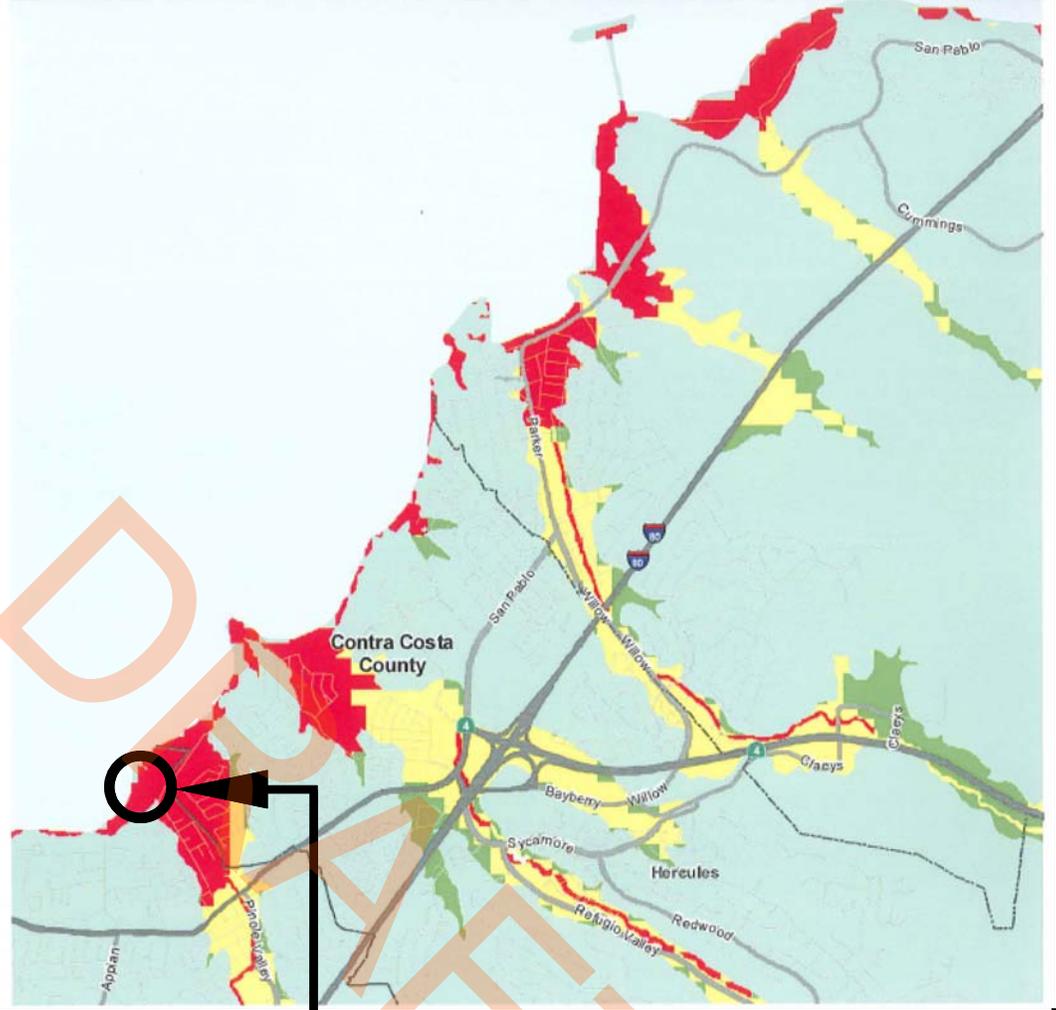
Liquefaction Hazard Map

This map is intended for planning use only and is not intended to be site-specific. Rather, it depicts the general hazard level of a neighborhood and the relative hazard levels from community to community. Hazard levels are less likely to be accurate if your neighborhood is on or near the border between two zones. This information is not a substitute for a site-specific investigation by a licensed professional.

PROJECT AREA
